## **PRELIMINARY REPORT ON ACCIDENT INVOLVING AGUSTAWESTLAND AW139 HELICOPTER OPERATED BY CAVERTON HELICOPTERS LIMITED WITH NATIONALITY AND REGISTRATION MARKS 5N-CML WHICH OCCURRED AT KABBA STADIUM, KOGI STATE ON 2<sup>ND</sup> FEBRUARY, 2019**

<b>Registered Owner and Operator:</b>	Caverton Helicopters Limited
<b>Aircraft Type and Model:</b>	AgustaWestland AW139
<b>Manufacturer:</b>	AgustaWestland
<b>Date of Manufacture:</b>	May 2012
<b>Nationality and Registration Marks:</b>	5N-CML
<b>Serial Number:</b>	31389
<b>Location:</b>	Kabba Football Stadium 7°50'31"N 6°04'41"E
<b>Date and Time:</b>	2 <sup>nd</sup> February, 2019 at about 14:34 h <i>(All times in this report are local time (UTC +1) unless otherwise stated)</i>

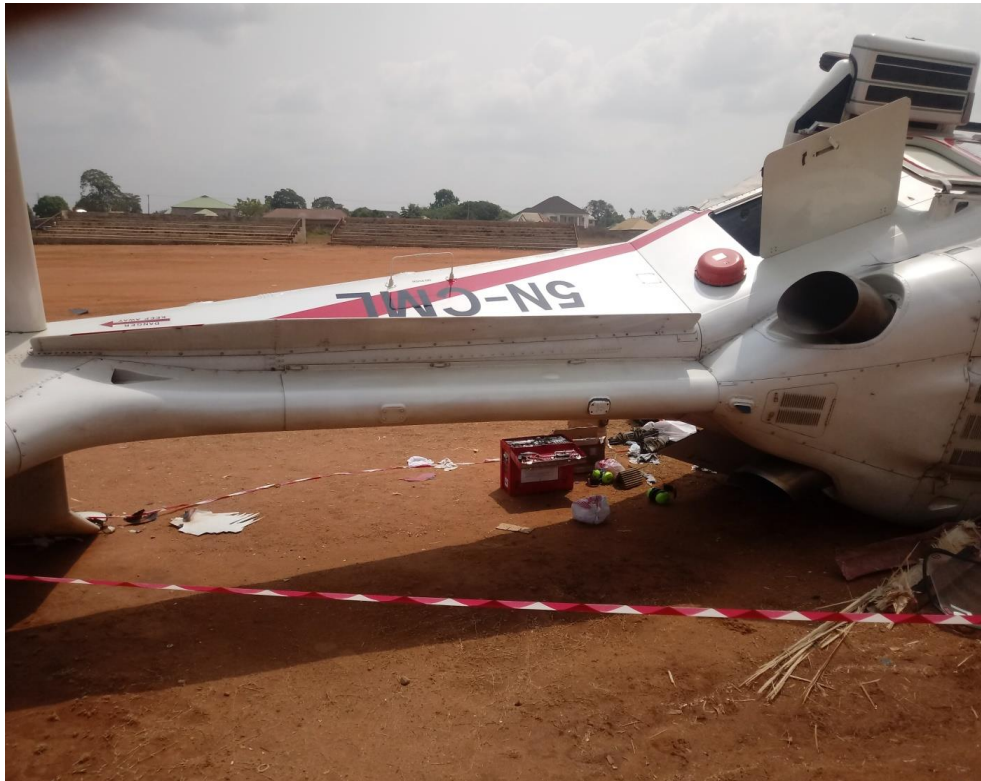
The helicopter was substantially damaged.

**Figure 1:** Photo showing part of the helicopter wreckage.

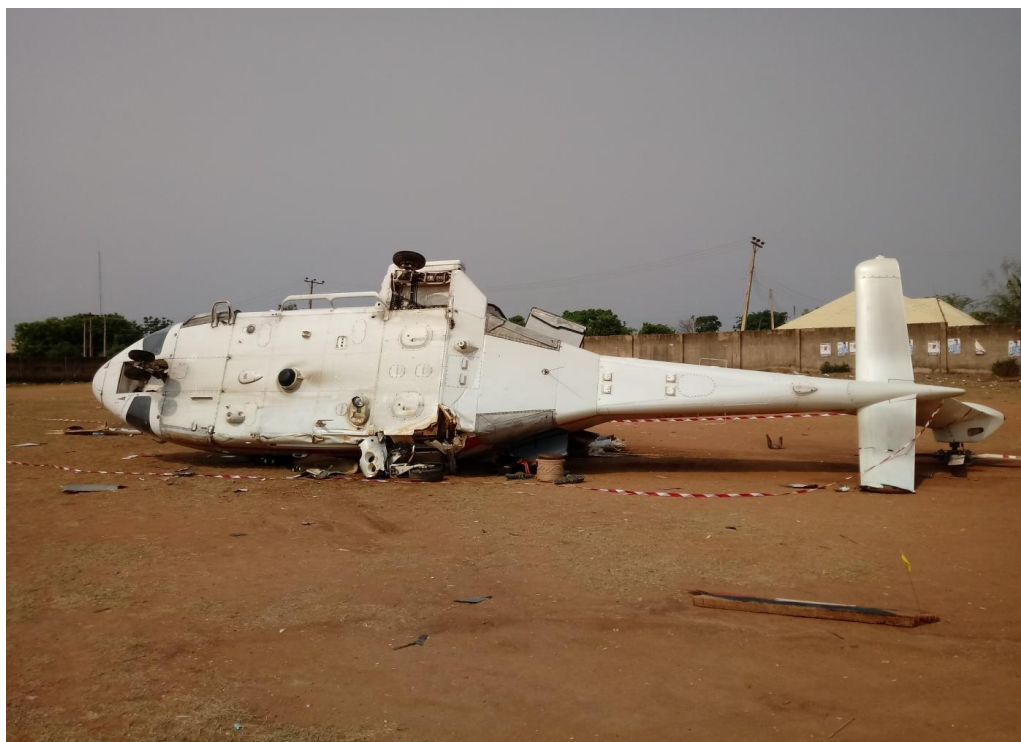
**Figure 2:** Photo showing the helicopter main wreckage.

The five main rotor blades separated from the rotor head and were destroyed, and debris was distributed within the football stadium. The right main landing gear was damaged, the right horizontal stabilizer was damaged, and the tail rotor blades suffered multiple damage, but the assembly remained intact. The life raft deployed while the left and the right floating devices did not deploy.
