AIRCRAFT ACCIDENT REPORT

NESTOIL/2018/01/25/F

**Report on the Serious Incident involving
Gulfstream G200 Aircraft Operated by Nestoil PLC with
Nationality and Registration Marks 5N-BTF which
occurred at Nnamdi Azikiwe International Airport, Abuja
On 25th January, 2018**

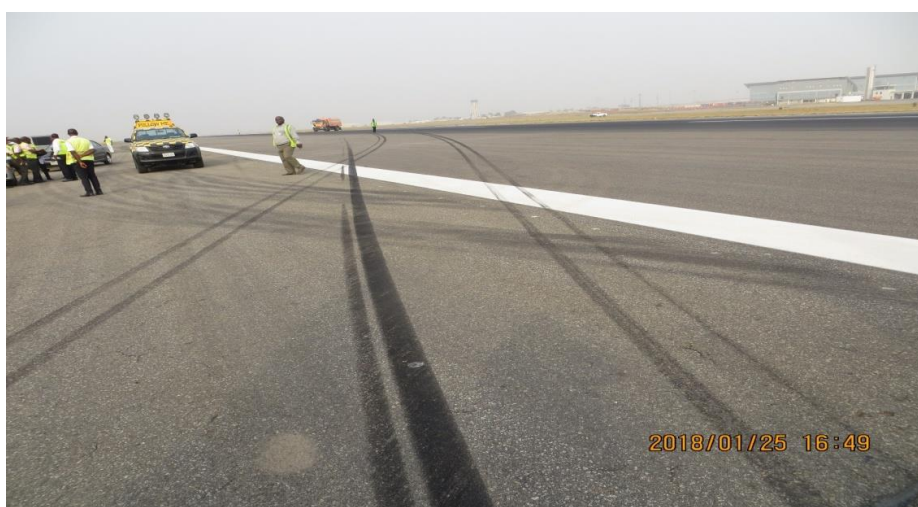
During the post-crash inspection, the investigation determined that the skid marks on the runway indicated that the aircraft steered in an S-pattern continuously with increasing

amplitude, down the runway. On the last right turn, the aircraft exited the right shoulder of the runway, the right main wheel went into the grass and on the final left turn, the right main landing gear strut detached from its main attachment point after which the aircraft finally came to a complete stop on a magnetic heading of 160°.

Figure 1: Aircraft tyre marks on the runway

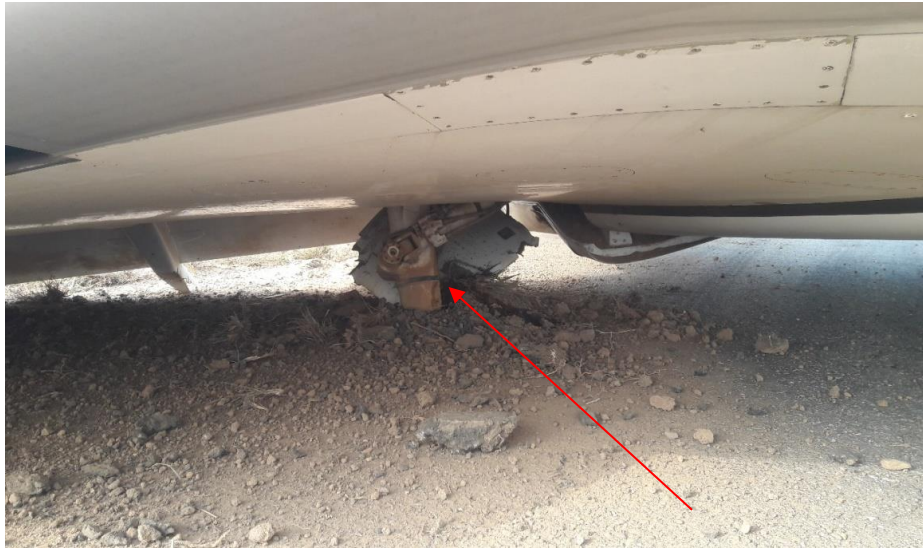
On the last right turn, the right main wheel went into the grass and on the final left turn, the right main landing gear detached from its attachment point and the lower surface of the right wing was abraded. The aircraft came to a stop at a distance of 1,953 m from the threshold of Runway 22. The distance as measured from the detached right main landing gear to the main wreckage was 10.8 m.

Figure 2: Photo showing the Right Main Landing Gear attachment point

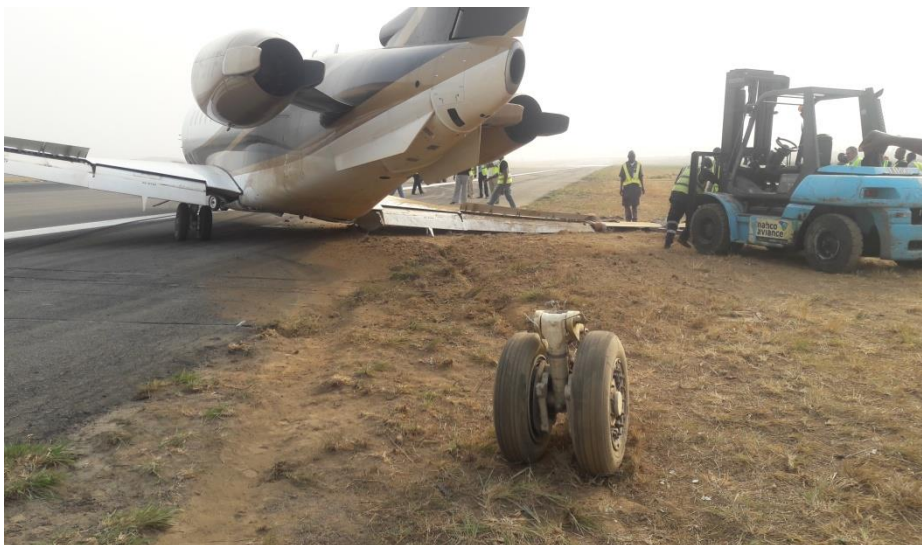
Figure 3: Part of the detached Right Main Landing Gear Assembly

This indicated that when the aircraft was making the S-turns there was transfer of load between the main landing gears which might have induced certain stress on the landing gears. On the last left turn, the aircraft exited the right shoulder of the runway when the right main wheel dropped unto the grass from the pavement leading to more stress on the landing gear in addition to the continuous application of brakes by the crew. The Right main Landing Gear (RLG) detached at a point when the entire aircraft loads were momentarily supported by it.

However, the nature of the failure of the landing gear for this particular occurrence is undetermined.

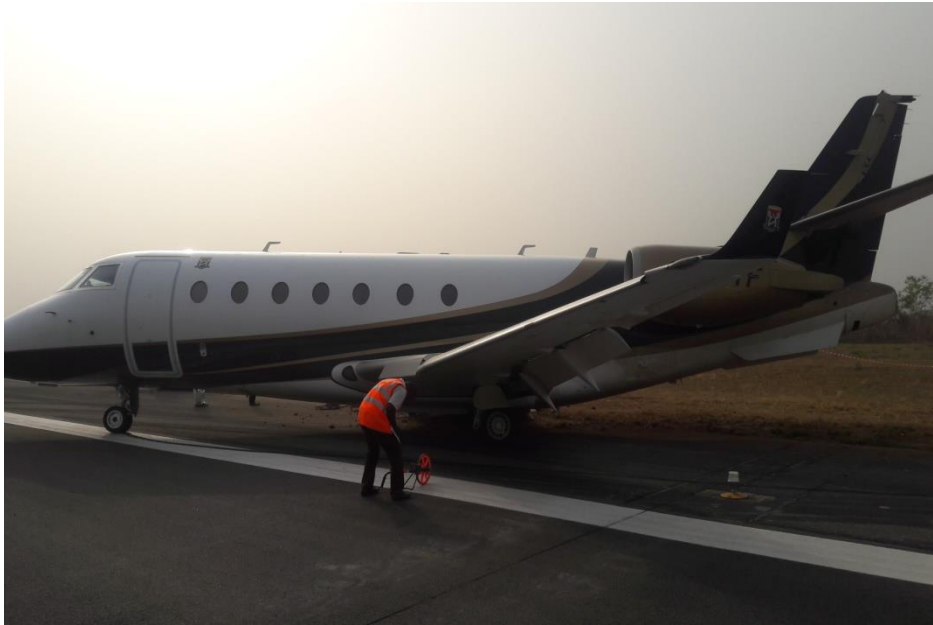
Figure 4: Aircraft final resting point

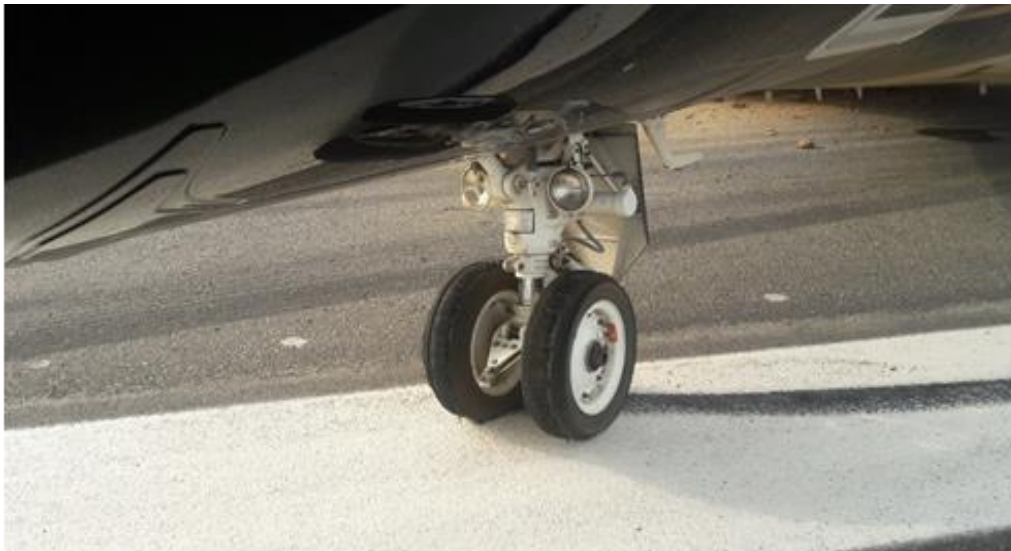
The aircraft fuselage was in one piece, but the landing gear assembly was detached. The nose landing gear tyres were abraded crosswise and the right inboard main wheel tyre was found deflated. Skid marks of the nose landing gear indicate that the aircraft landed 6 m left of the runway centre line, travelled in an S-pattern with increasing amplitude down the runway.

Figure 5: Nose wheel tyre chaffed

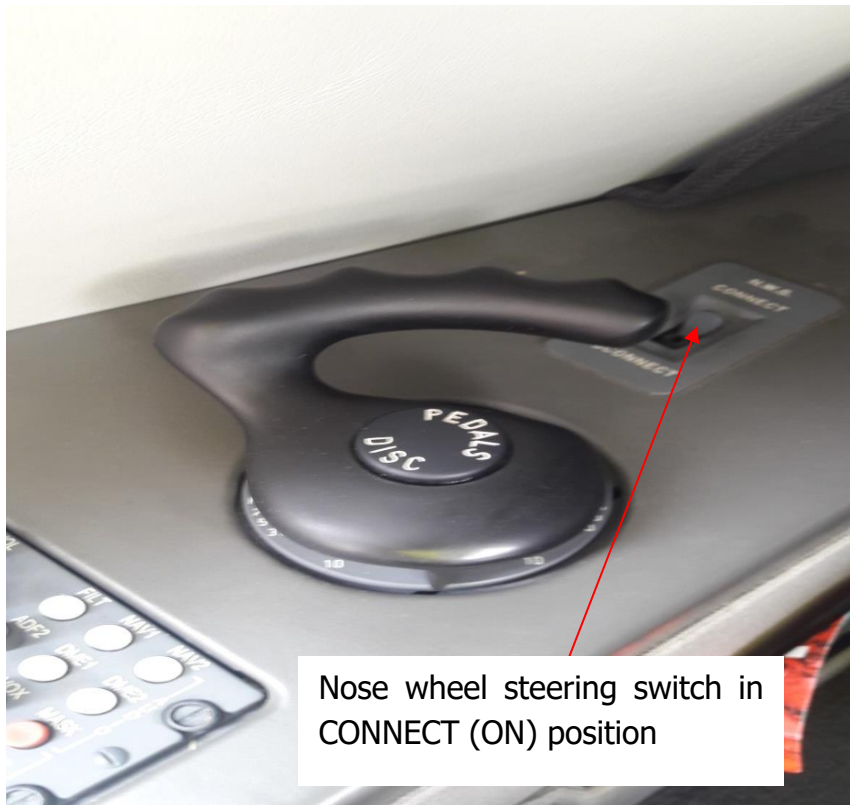
Figure 6: Nose wheel steering control and switch

An NWS toggle switch on the left console in the cockpit allows the pilot to activate the NWS system or to switch it off and place the nose landing gear in a free swivel mode for shimmy damping. The switch was found to be in the CONNECT (ON) position after the incident. Any single failure in the NWS, which may impact aircraft safety, is detected by

the Failure Detection and System Protection. If a hazardous situation is detected, the system is transferred to bypass mode, and in that mode aircraft directional control is accomplished by means of differential braking and/or rudder control. The activation of this protection system displays a "NWS INOP" message on the Crew Alerting System and in this incident there were no messages on the crew alerting system. In the event that the NWS switch is in the OFF position or the system is transferred to bypass mode due to a failure, the nose wheel will be in a free swivel mode and will castor in the aircraft direction. On examination of the nose wheel tires, transverse abrasions were found indicating that the NWS was being controlled and not in the free swivel mode.

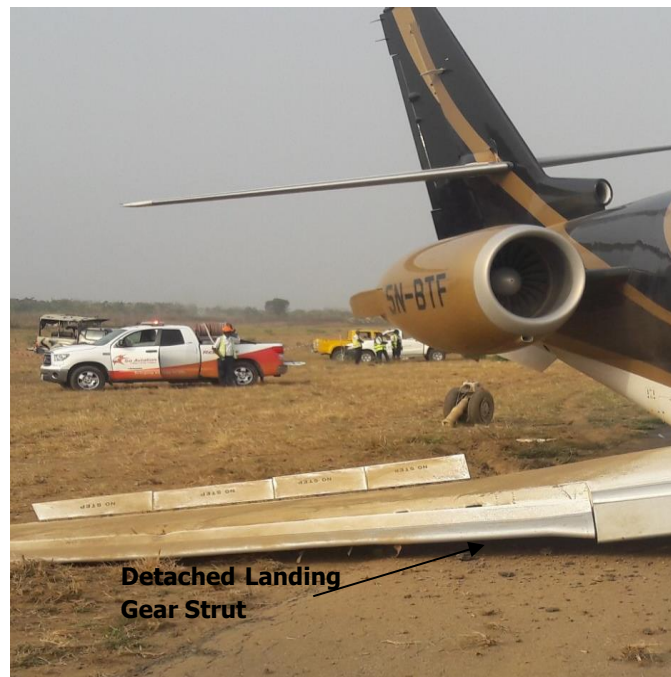
Figure 8: The detached landing gear in relation to the final resting position of the aircraft
