**PRELIMINARY REPORT ON INCIDENT INVOLVING TAMPICO CLUB TB-9 AIRCRAFT OPERATED BY NIGERIAN COLLEGE OF AVIATION TECHNOLOGY (NCAT), ZARIA WITH NATIONALITY AND REGISTRATION MARK 5N-CBP WHICH OCCURRED AT RUMA VILLAGE, BIRNIN-GWARI LOCAL GOVERNMENT AREA, KADUNA STATE ON 1<sup>st</sup> MARCH, 2019**

**Nationality and Registration Marks:** 5N-CBP

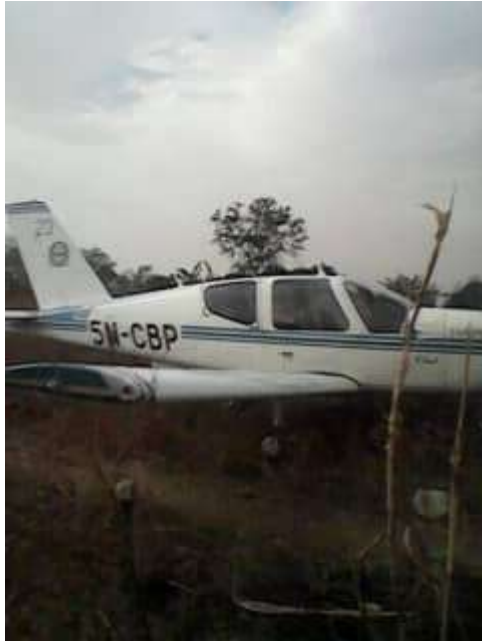
There was no visible damage to the aircraft after the forced landing.

Fig 1: The aircraft on the farmland after the forced landing

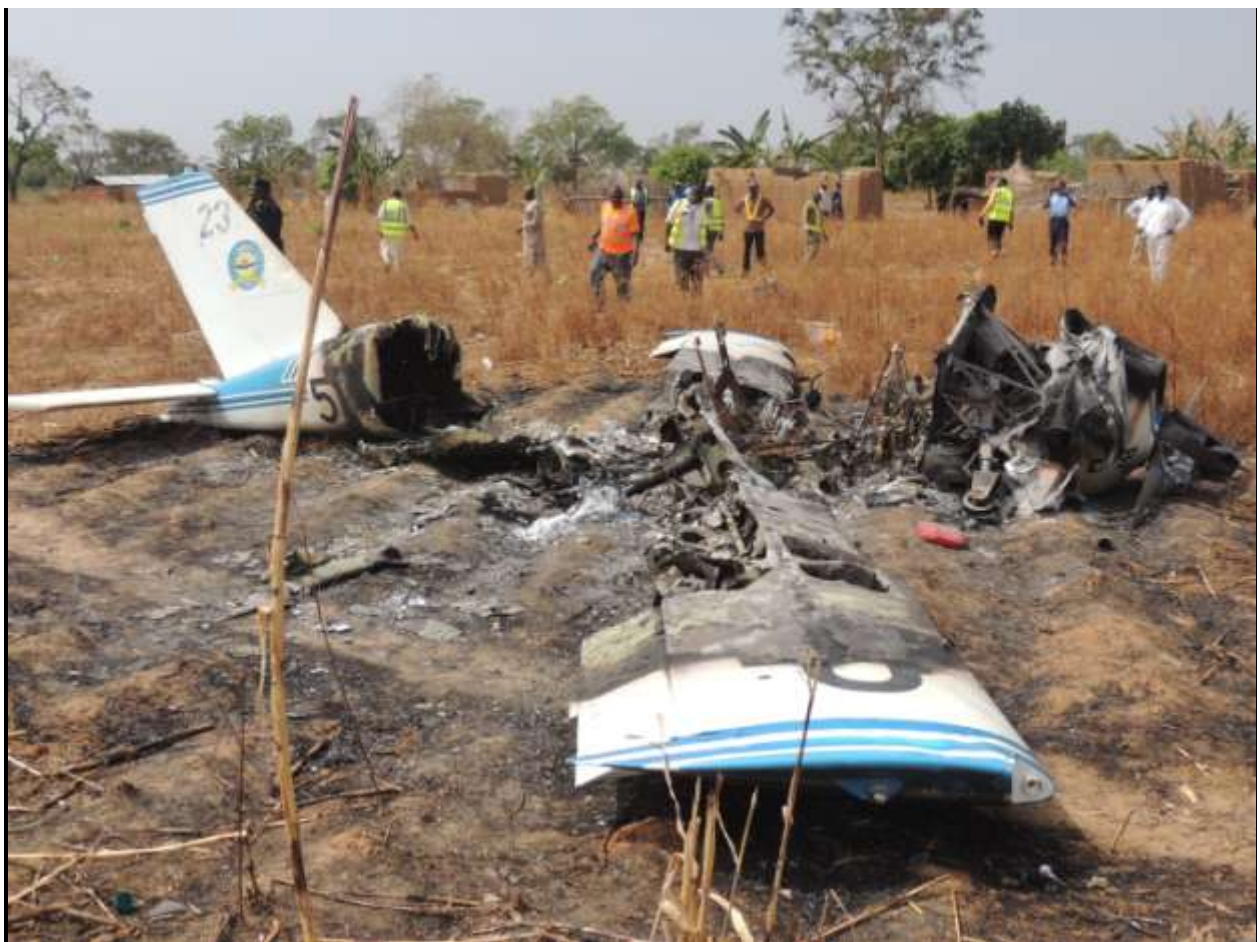
The aircraft was set a result of shootings by Rustlers.

**Figure 2: Side view of the burnt aircraft**

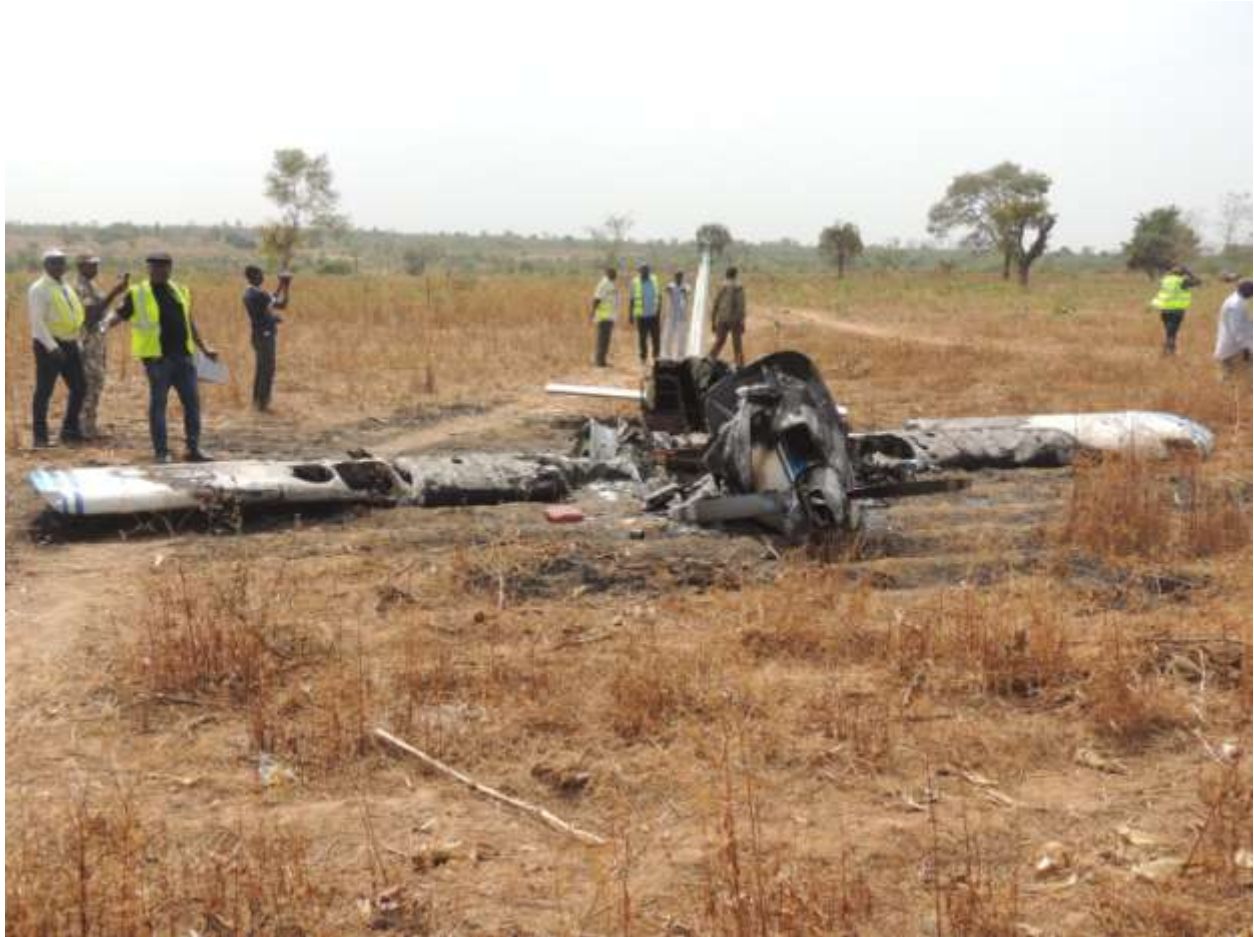
**Figure 3: Front view of the burnt aircraft**

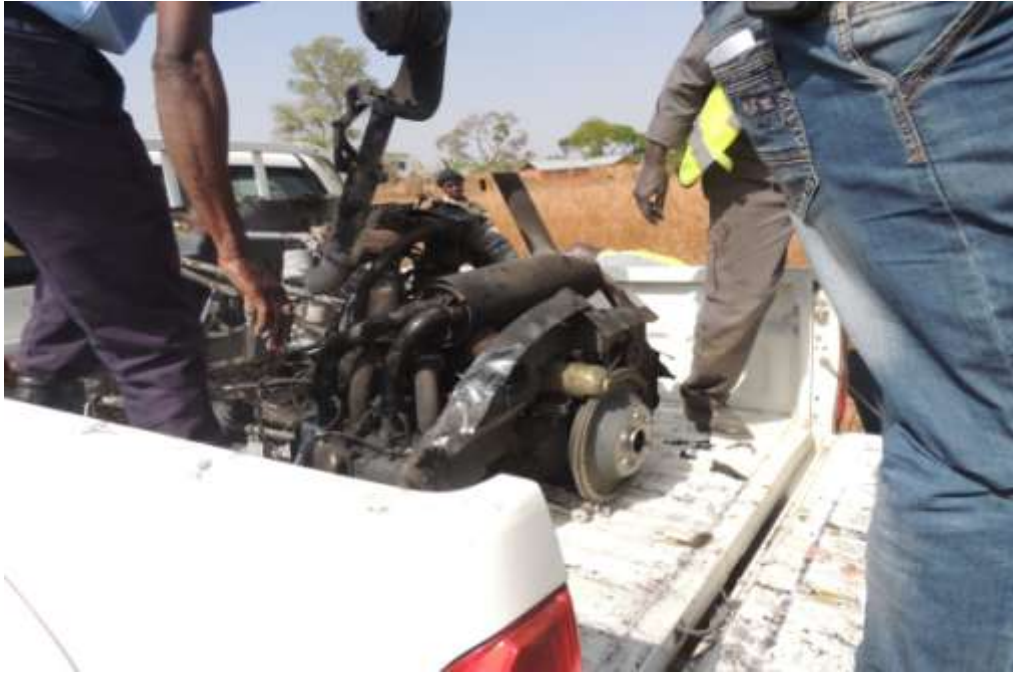
**Figure 4: The burnt engine recovered from the aircraft**

10. The aircraft was set a result of shootings by Rustlers
11. The engine sustained fire damage
12. The accident occurred at Ruma village, Sabon–Birni in Birnin Gwari LGA, Kaduna State, which is 7.5nm NW of Kaduna Airport.
