AIRCRAFT ACCIDENT REPORT

NESTOIL/2018/01/25/F

**Report on the Serious Incident involving
Gulfstream G200 Aircraft Operated by Nestoil PLC with
Nationality and Registration Marks 5N-BTF which
occurred at Nnamdi Azikiwe International Airport, Abuja
On 25th January, 2018**

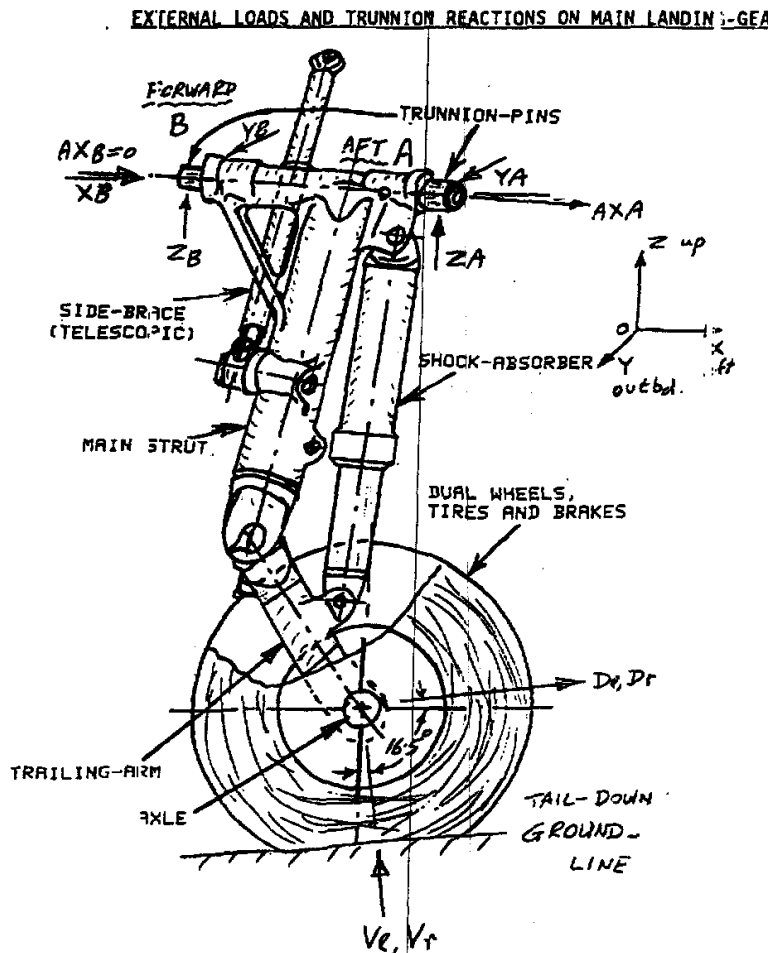
Figure 7: Schematic Diagram of the Main Landing Gear

It is recommended that the strength of the back-up structure be evaluated under these estimated main gear failure loads. If the back-up structure can withstand these loads, compliance with FAR 25.721 is assured. Even if this is not completely met, the above

description of the mode of gear separation following the failure enables this airworthiness requirement to be satisfied.
